Honeywell

After Hours Report FDA White Oak

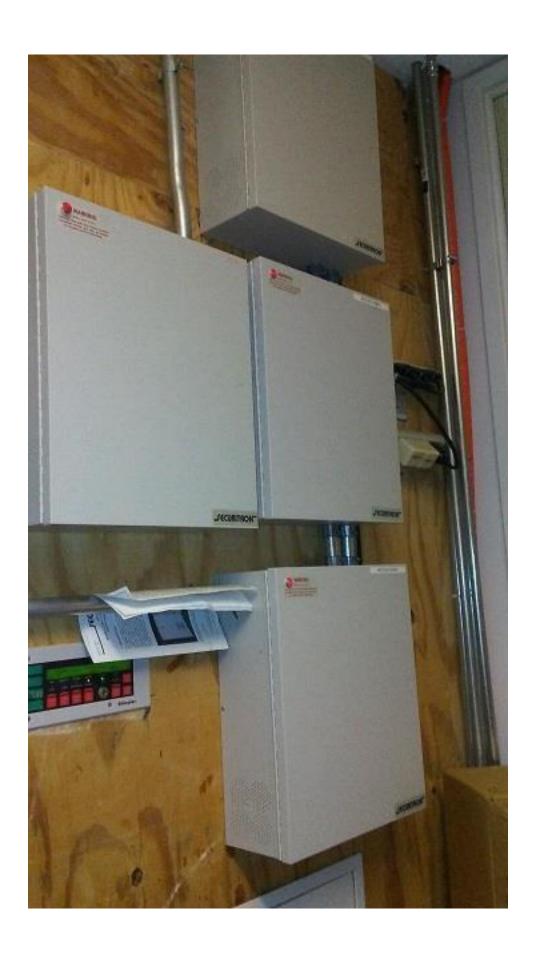
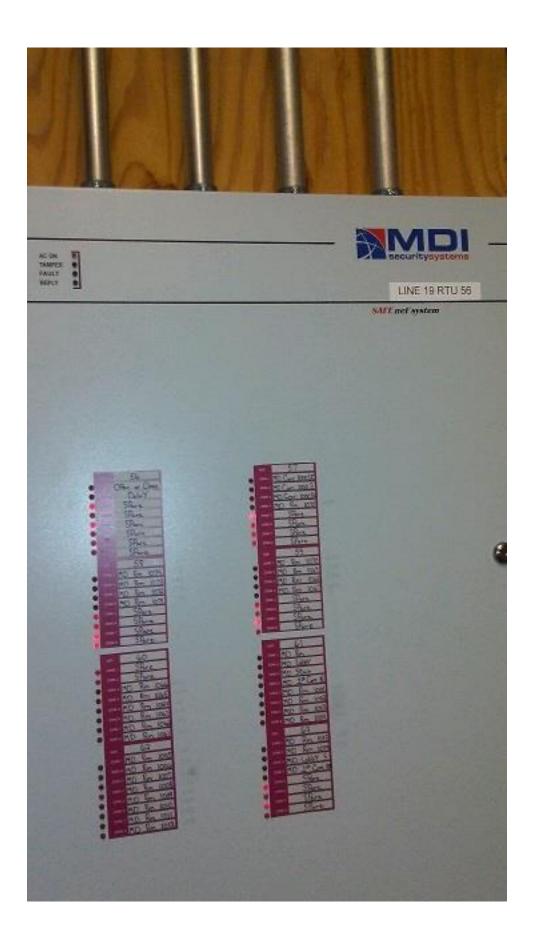
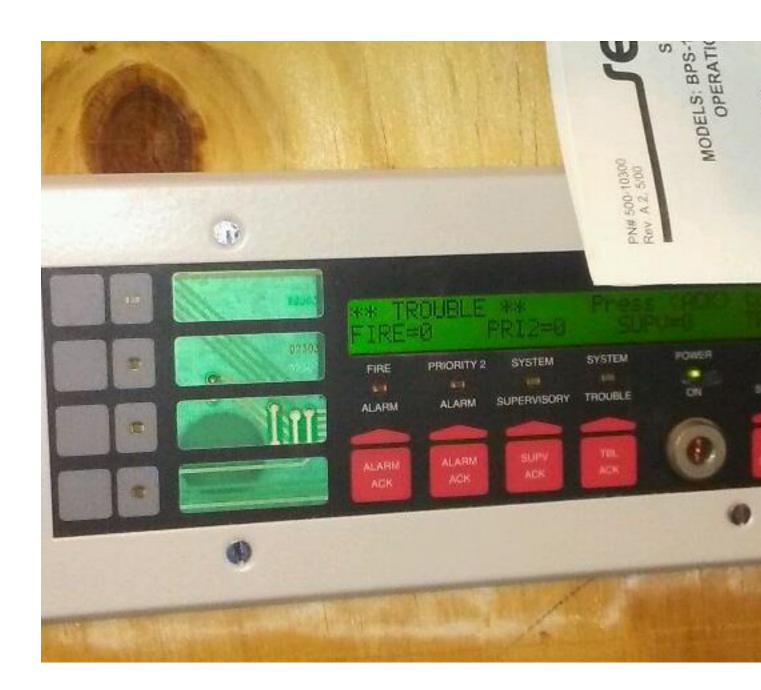
Approximately 9:30 pm received call from the command center regarding an alarm emanating from room 1010 in Building 64. A technician was dispatched to the room and found a MDI security panel in alarm, along with a Simplex panel with a trouble code. Security was present and did not know the purpose of the panels. See Pictures.

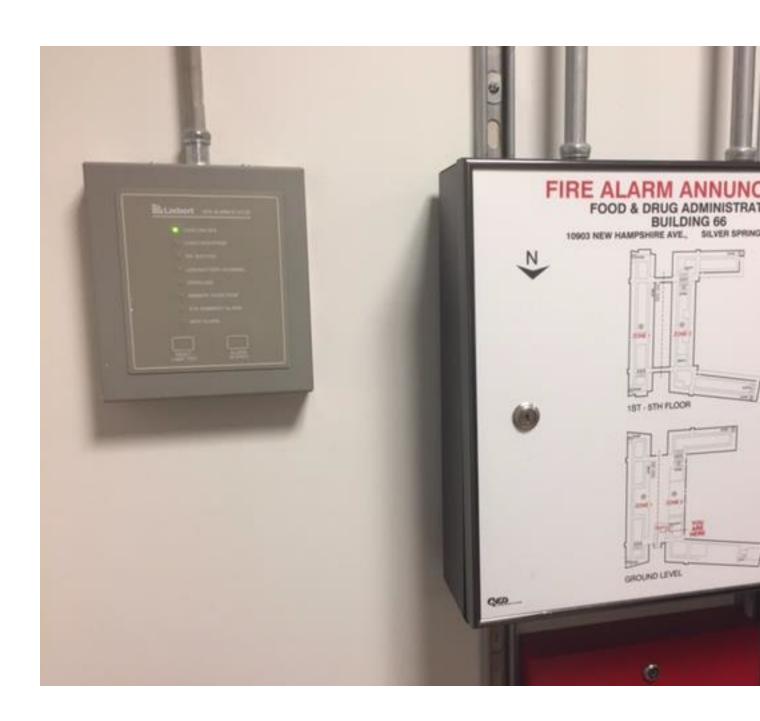
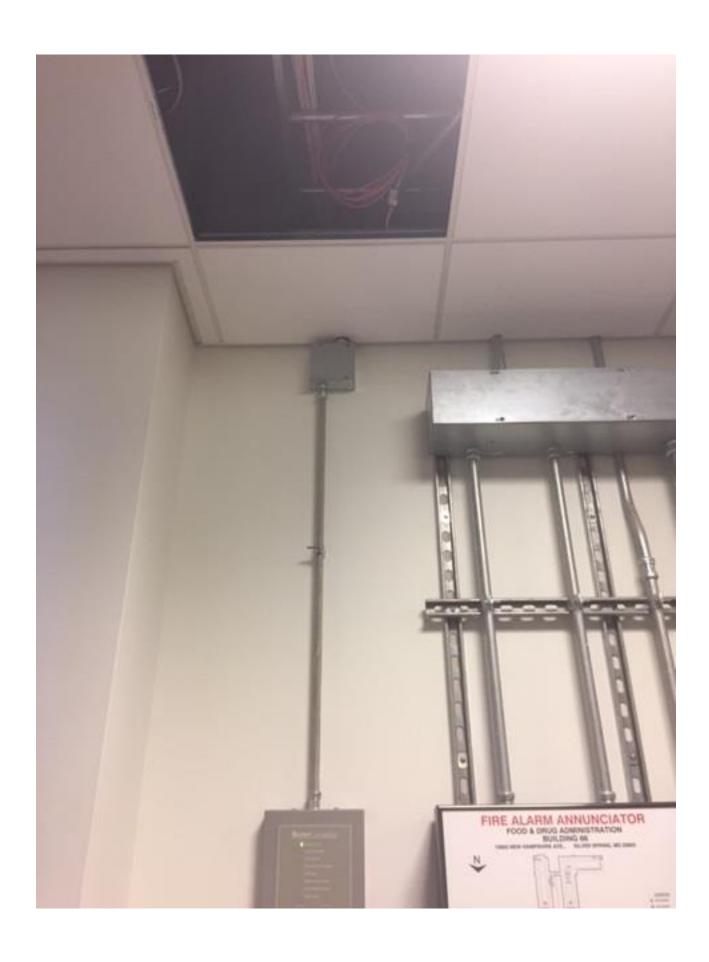
Approximately 6:30 pm received call from the command center regarding an alarm emanating from the guard room at the main entrance of Building 66. A technician was dispatched to the room and found a small UPS Liebert panel in alarm, next to a fire alarm panel. The alarm sound was silenced, and successfully reset. The small panel is not tagged and tracing the electrical conduit in the ceiling showed that it heads towards the MOP rooms – of which we do not have access. We did find nearby breakers tripped for camera's, blue lights, and reset them, but approximately one hour later the alarm was present again, so we suspect that was unrelated. See Pictures.

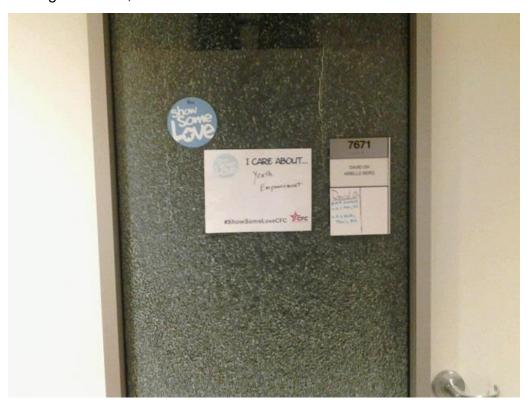
Approximately 7:15 pm received call from the command center regarding a broken window in room 7671 of Building 75. We found the sidelight window next to the entry door of the room was completely shattered – it is safety glass and therefore does not crack, but shatters into tiny pieces, but remains in place. We covered both sides with cardboard and tape to prevent injury should the shattered pane fall apart. This will require replacement by a glass company. Jun Dimayuga was still on site, building manager for B75, and also took a look at this issue.

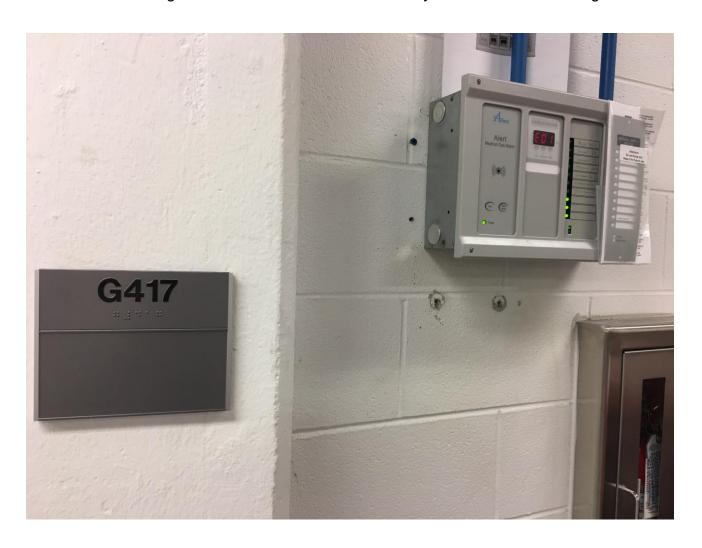
Approximately 7:20pm a Honeywell branch employee noticed a C02 panel in Mech rm G417 in alarm during his tour. The room is in the hallway behind the B52 loading dock.

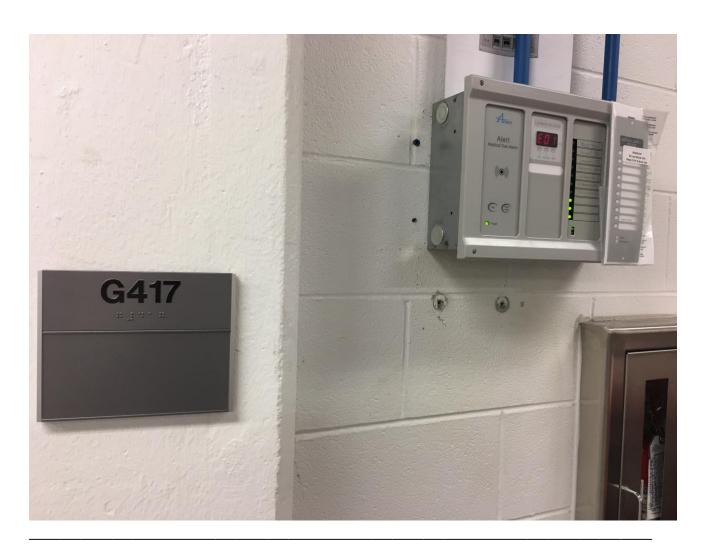
At approximately 7:45pm during a scheduled tour we noticed the C02 panel in B52 Mech rm G417 in alarm again. This is the same alarm that was found on last Thursday the 23^{rd.} We manually silenced the alarm – it is quite loud.

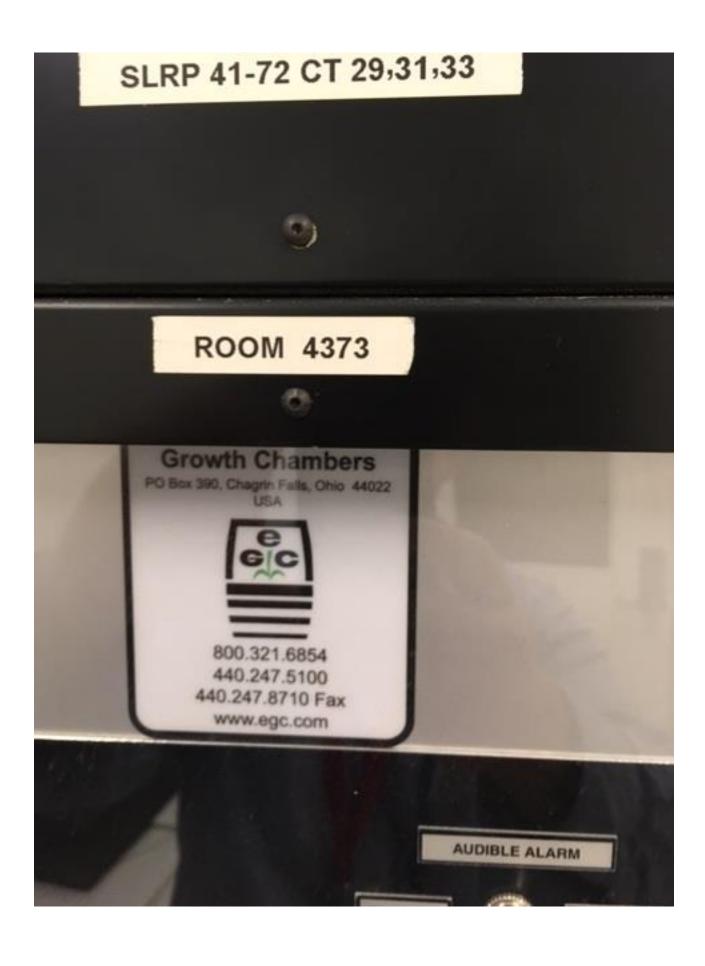
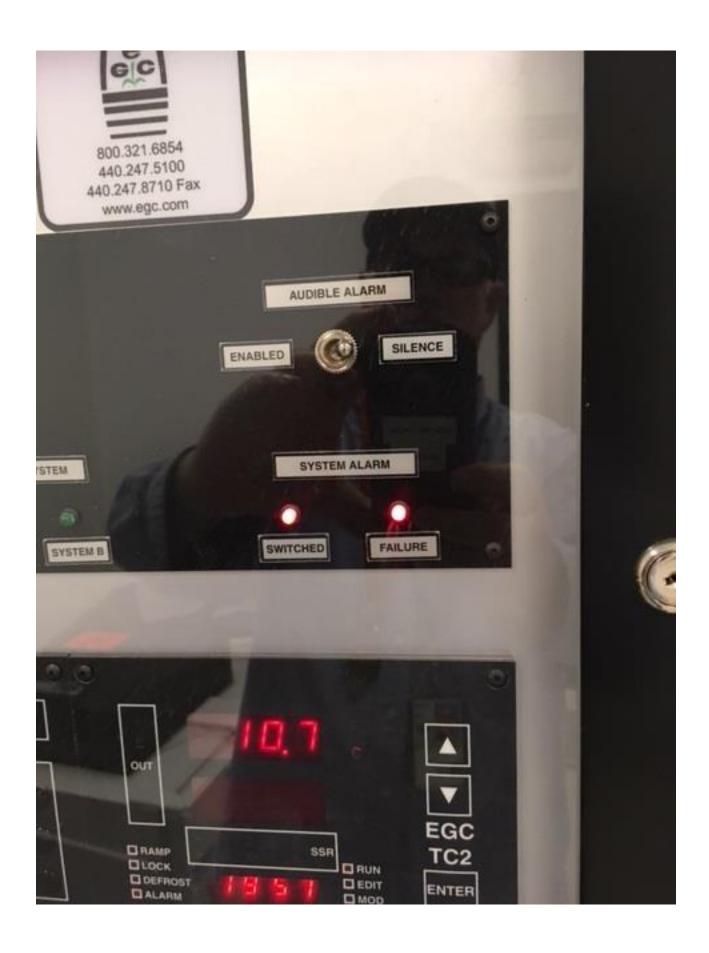
Cold room #8401 was found in "system alarm". Associated room 4373. This came to the attention of a Nova Electrician responding to a call about the lights not working in room 4375. Contacts listed on the card for the cold room were contacted and messages left for Sreenivas Gannavaram, and the phone number for Francine Wood was no good (301-451-3985), but a message was left on her office number (240-402-7486) Pictures attached

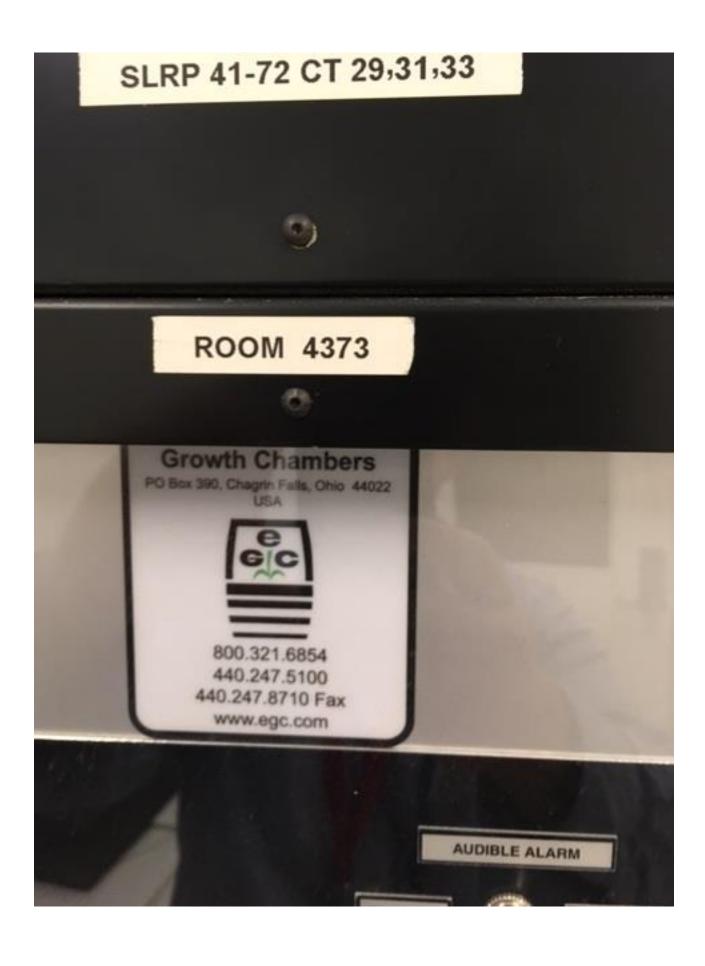
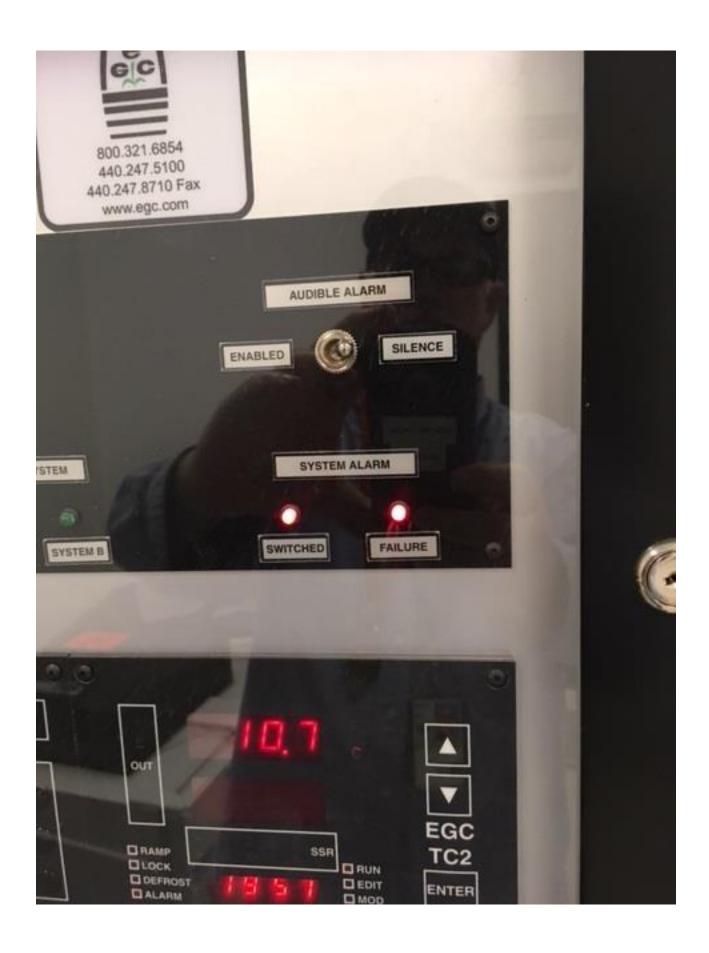
Cold room #8401 was found in "system alarm". Associated room 4373. This came to the attention of a Nova Electrician responding to a call about the lights not working in room 4375. Contacts listed on the card for the cold room were contacted and messages left for Sreenivas Gannavaram, and the phone number for Francine Wood was no good (301-451-3985), but a message was left on her office number (240-402-7486) Pictures attached

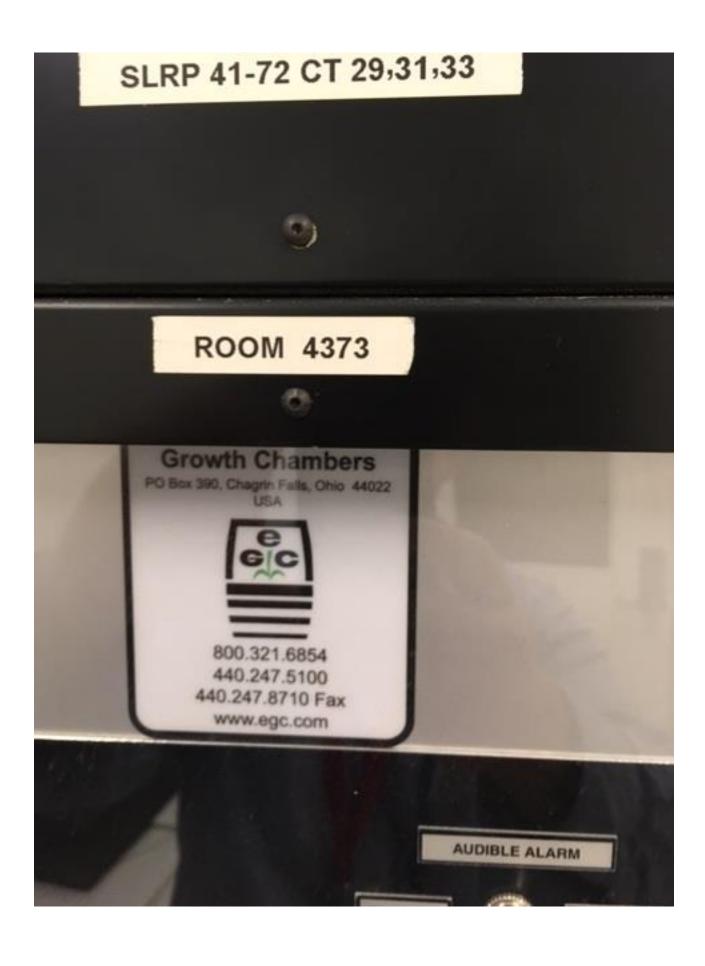
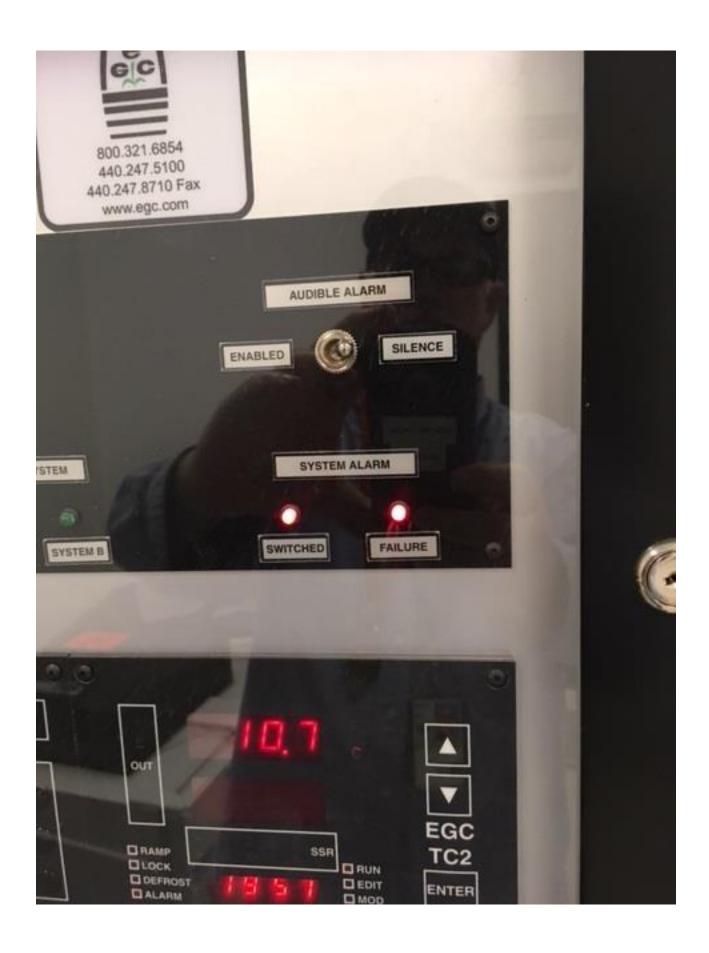
Cold room #8401 was found in "system alarm". Associated room 4373. This came to the attention of a Nova Electrician responding to a call about the lights not working in room 4375. Contacts listed on the card for the cold room were contacted and messages left for Sreenivas Gannavaram, and the phone number for Francine Wood was no good (301-451-3985), but a message was left on her office number (240-402-7486) Pictures attached
